# State of Utah DEPARTMENT OF NATURAL RESOURCES Division of Oil, Gas & Mining

## **Inspection Report**

## Minerals Regulatory Program November 8, 2007

Mine Name: New-6	Permit number: S270111
Operator Name: Alan Newman	<b>Inspection Date:</b> 10/25/200

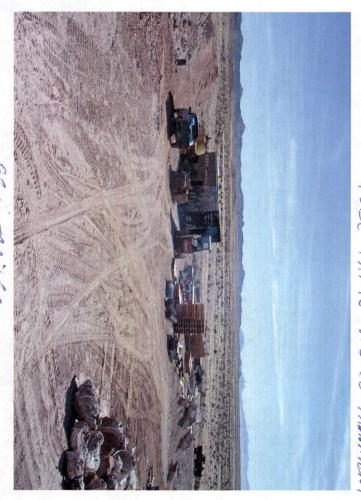
SEMI TRAILER

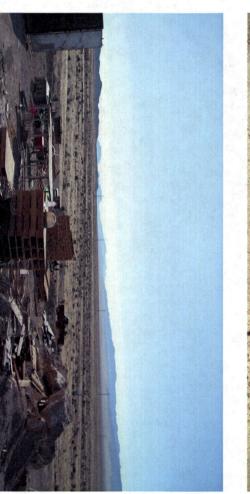
PALESS + WOOD DEBRIS

The main problems at the site that need immediate attention is the fuel storage needs containment for spills and oil changes of equipment needs to be done in a safe containment area. Overall site cleanup needs to occur. Since the site has expanded to 3.2 acres and is only bonded for 3 acres, the areas outside the 3 acres need to be bonded or cleaned up and seeded. It now becomes imperative these items are taken care of before the next inspection or a cessation order will be written and the appropriate enforcement actions taken .

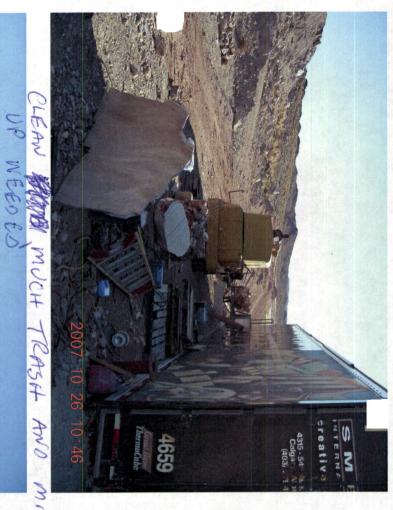
MISCENTANOUS DEBRY

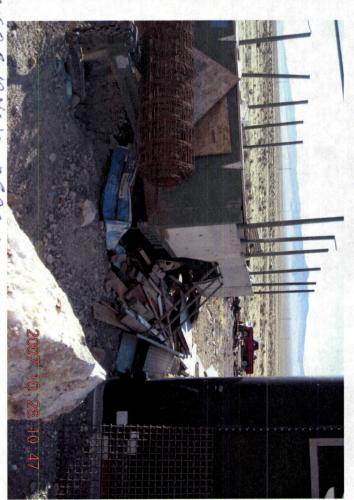
Oil spice
